**Flood Control Project Maintenance
Levee Inspections**

Maintenance Issue Types Only, Levee Inspection Report By Mile - Spring 2019

Solano County Public Works Mellin Levee

Waterway	Bank	Unit Miles	Inspection Start/End	Inspector
Unit No. 01 Mellin Levee	Right	0.59	03/28/2019 03/28/2019	David Julian

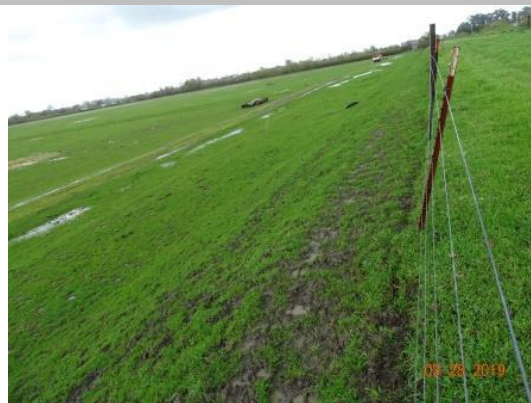
Photo 1 of 1 : SP_2019_NA0012_258_10_20190329_00008.jpg

LM Start	0.00	Rating **	M	Issue No.	10
LM End	0.34	Issue Type +	Ma	Location *	WS
Category	Earthen Levee			GPS Latitude/Longitude	
				Start	End
Item	Slope Stability			38.174067 °	38.177508 °
				-121.674271 °	-121.678675 °
DWR ID	DWR_NA0012_01_s_2019_10				
Comment Code					
S1 : Repair slope instability.					
Inspector Comment					
Repair instabilities caused by cattle walking on the waterside slope.

View of slope instabilities caused by cows on the waterside slope (Spring 2019).

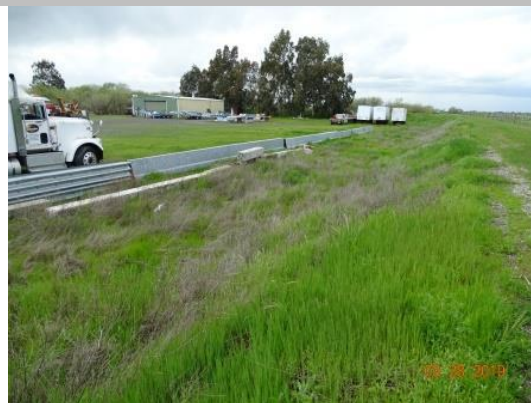
Photo 1 of 1 : SP_2019_NA0012_258_2_20190329_00006.jpg

LM Start	0.02	Rating **	M	Issue No.	2
LM End	0.37	Issue Type +	Ma	Location *	LS
Category	Earthen Levee			GPS Latitude/Longitude	
				Start	End
Item	Vegetation			38.174202 °	38.177746 °
				-121.674435 °	-121.679021 °
DWR ID	DWR_NA0012_01_s_2019_2				
Comment Code					
V1 : Control annual grass and weeds on the levee slopes and easements.					
Inspector Comment					
Maintain the annual vegetation on the landside slope.

View of annual vegetation on the landside slope (Spring 2019).

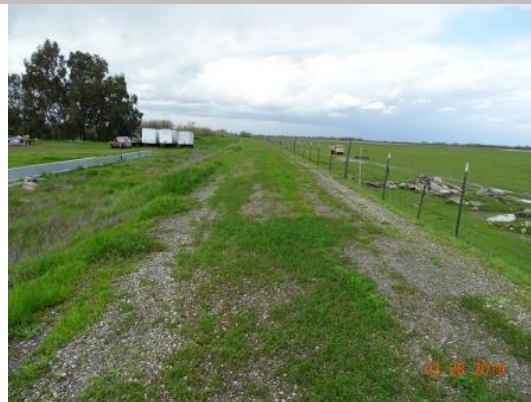
Photo 1 of 1 : SP_2019_NA0012_258_8_20190329_00007.jpg

LM Start	0.02	Rating **	M	Issue No.	8
LM End	0.59	Issue Type +	Ma	Location *	CR
Category	Earthen Levee			GPS Latitude/Longitude	
				Start	End
Item	Vegetation			38.174201 °	38.180059 °
				-121.674441 °	-121.681966 °
DWR ID	DWR_NA0012_01_s_2019_8				
Comment Code					
V1 : Control annual grass and weeds on the levee slopes and easements.					
Inspector Comment					
Remove the annual vegetation from the crown.

View of vegetation on the crown (Spring 2019).

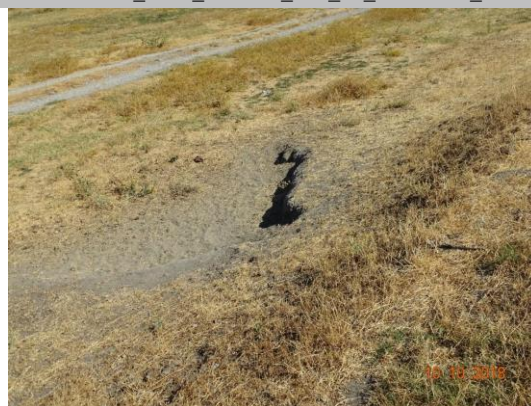
Photo 1 of 1 : SP_2019_NA0012_258_11_20190311_00005.jpg

LM Start	0.13	Rating **	U	Issue No.	11
LM End	0.13	Issue Type +	Ma	Location *	WS
Category	Earthen Levee			GPS Latitude/Longitude	
				Start	End
Item	Slope Stability			38.175355°	38.175355°
				-121.675833°	-121.675833°
DWR ID	DWR_NA0012_01_f_2018_11				
Comment Code					
S2 : Repair the levee slope damaged by foot traffic and prevent access where possible.					
Inspector Comment					
Cows are digging into the waterside toe.

View of erosion into waterside toe (October 2018).

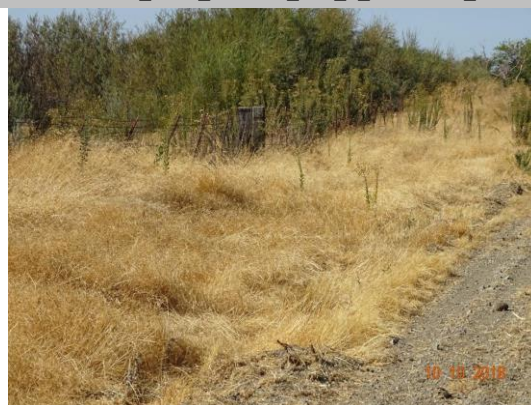
Photo 1 of 1 : SP_2019_NA0012_258_5_20190311_00004.jpg

LM Start	0.18	Rating **	U	Issue No.	5
LM End	0.25	Issue Type +	Ma	Location *	LS
Category	Earthen Levee			GPS Latitude/Longitude	
				Start	End
Item	Vegetation			38.175925 °	38.176615 °
				-121.676618 °	-121.677528 °
DWR ID	DWR_NA0012_01_f_2018_5				
Comment Code					
V1 : Control annual grass and weeds on the levee slopes and easements.					
Inspector Comment					
Remove vegetation up to fence on the landside slope.

View of vegetation on the landside slope (October 2018).
